# Waipawa WwTP - Preliminary Stage 1 Review

Prepared for Central Hawkes Bay District Council

Prepared by Beca Limited

18 December 2017

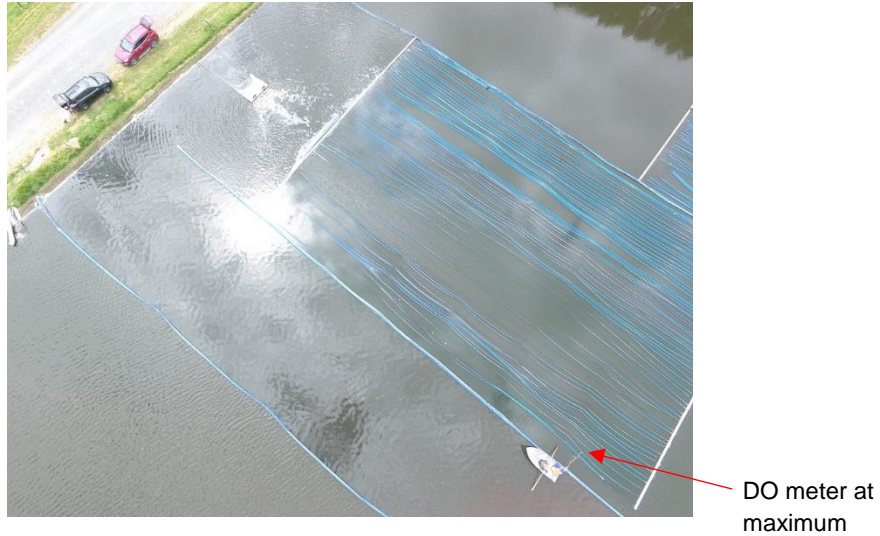
- BAS Media Curtains: On 14/11/2017 we took additional spot DO readings with a hand held DO meter. These included taking readings within the BAS Media curtains to determine if the aerators are actually aerating the media which is supposed to support the nitrifying bacteria. Dissolved oxygen along the outer extremities of the curtains appeared healthy, typically ranging from 4 mg/l to 9 mg/l, but most commonly between 4 and 5mg/l. However, when we put the DO meter into that area more than 2 or 3 curtains in from the outer edge, the DO was typically in the range 1.0 to 2.0 mg/l and significantly lower toward the bottom than the top of the curtains. This indicated that there was a little oxygen transfer at the surface, probably due to wind action, but virtually none through the bulk of the curtains. For safety reasons, we could not get the D.O meter more than about 3 or 4 rows in from the outside (Refer figure 3). In that environment, it is very unlikely the nitrifying bacteria would colonize or proliferate.

Figure 3 – Dissolved Oxygen Monitoring in the BAS Nitrification Zone

- Determine the fate of the BAS media curtains. If these are to remain in place, the tensioning devices will all need to be replaced, in a suitable material in the near future

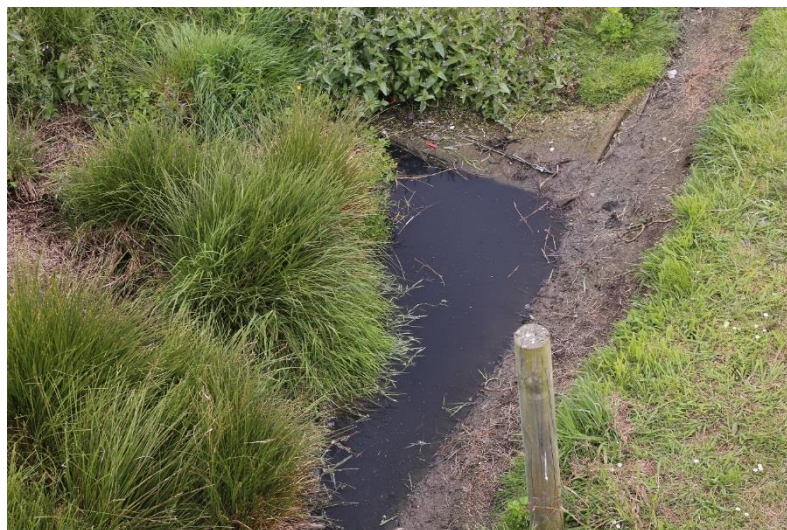
- SP4: The DO of the effluent leaving the floating wetland zone is very low, averaging 1.6mg/l. This is definitely not typical of effluent leaving a pond system and is symptomatic of a system that is receiving too little or no oxygen. The areas between the floating strips of planted wetland are completely covered over so that there is no transfer of oxygen possible between the atmosphere and the water. The spot measurement taken on 14/11/2017 was 0.2 mg/l and that taken on 26 May 2017 was 0.35mg/l. These indicate that the wetland area is borderline anaerobic. Indeed, the effluent is black in colour (Refer figure 4) and there is a distinct odour of hydrogen sulphide in the air. This is a strong indicator of septicity in wastewater. This effluent is then pumped up to the top of the lamella tower and there is again a strong odour as this is released to atmosphere and as the effluent flow enters the discharge launders

Figure 4 – Floating Wetland Discharge Area. Note Black Colouration of Effluent

4.2.3.2 The floating wetlands are achieving little to no additional treatment over that provided by the rest of the treatment plant. In fact, there is actually some degradation in quality through the wetlands as the effluent appears to become anaerobic as evidenced by very low dissolved oxygen readings, a black colouration to the effluent and the strong odour of hydrogen sulphide as the effluent is pumped up to the top of the Lamella clarifier tower. Performance statistics for the floating wetlands are provided in Table 6.

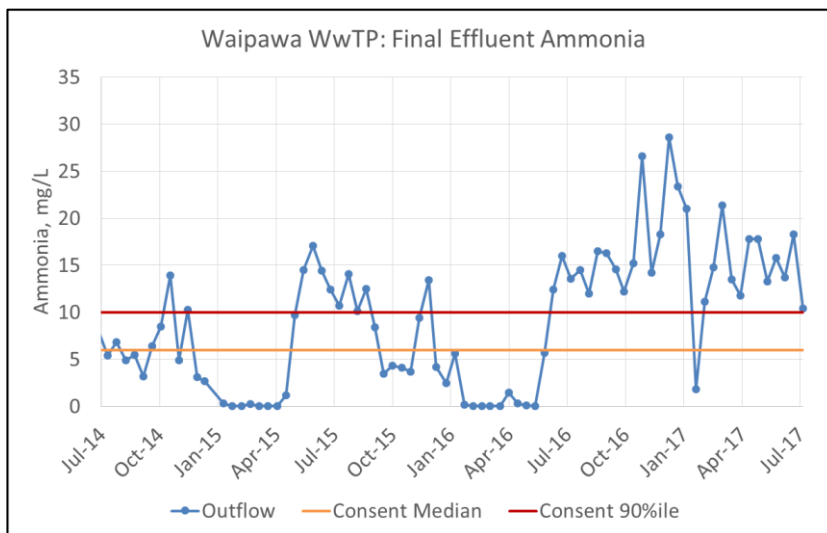
- Compliant with TSS resource consent requirements over the past three years. Refer TWWS 2017, figure 21
- Comfortably compliant with the cBOD<sub>5</sub> resource consent requirements over the past three years. Refer TWWS 2017, figure 22
- In the 2014/15 and 2015/16 summer periods, compliant with the Ammoniacal nitrogen resource consent requirements. However, as shown in Figure 5, the WWTP did not achieve sufficient ammonia removal during the corresponding winter periods. In addition, since June 2016, the ammonia resource consent conditions have not been met under either summer or winter conditions.

Figure 5 – Waipawa WwTP Final Effluent Ammonia

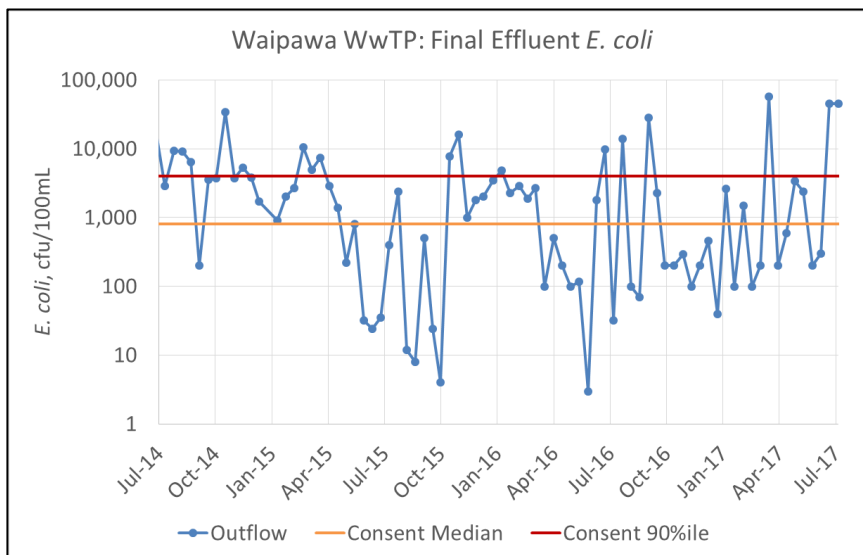
Figure 6 – Waipawa WwTP Final Effluent E.coli, 2014 - 2017

- The performance of the UV system at Waipawa has been inconsistent. While this may be partly due to changing effluent characteristics, it is also possible that UV system performance could be improved through more regular, scheduled maintenance. In addition to routine maintenance such as lamp, wiper and sleeve replacement, periodic manual cleaning of the quartz sleeves is required using dilute phosphoric acid to remove inorganic precipitates

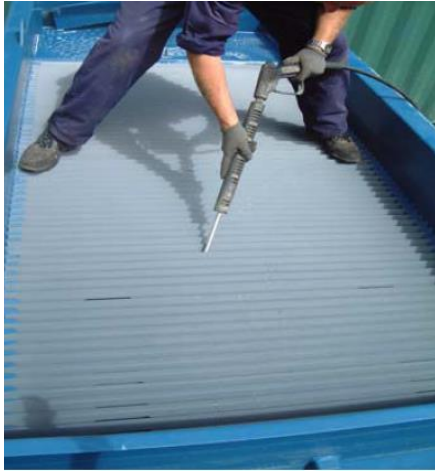
- Flocculated particles may be 'hanging up' on the top of the lamella plates and not sliding down to the hopper below. Eventually, this will constrict the flow passage to such an extent that the up-flow velocity prevents floc settlement. This could be remedied by instituting a regular cleaning cycle whereby the clarifier is drained down and a series of spargers is used to flush out the material from between the plates. Another possibility would be to find and experiment with a high frequency vibrating or ultrasonic device that is sufficient to cause the accumulated solids to loosen and slide off the plates

Figure 7 – Illustration of Lamella Plate Cleaning

- The lamella plates can be cleaned in situ provided the solids have not been allowed to build up for too long. Cleaning of the plates should be undertaken regularly with a pressure washer (refer figure 4 below).

- Implement a regular pressure cleaning regime on the lamella clarifier
- Optimise the performance of the lamella clarifier and sand filters. We understand that the lamella discharge launders have now (since 14 November 2017) been replaced with launders that utilize a high level V-notch weir system. It was demonstrated through the addition of polymer dosing after coagulation at Waipukurau, that it may be possible to improve TSS removal through the tertiary treatment processes which, in turn, may improve UV disinfection performance

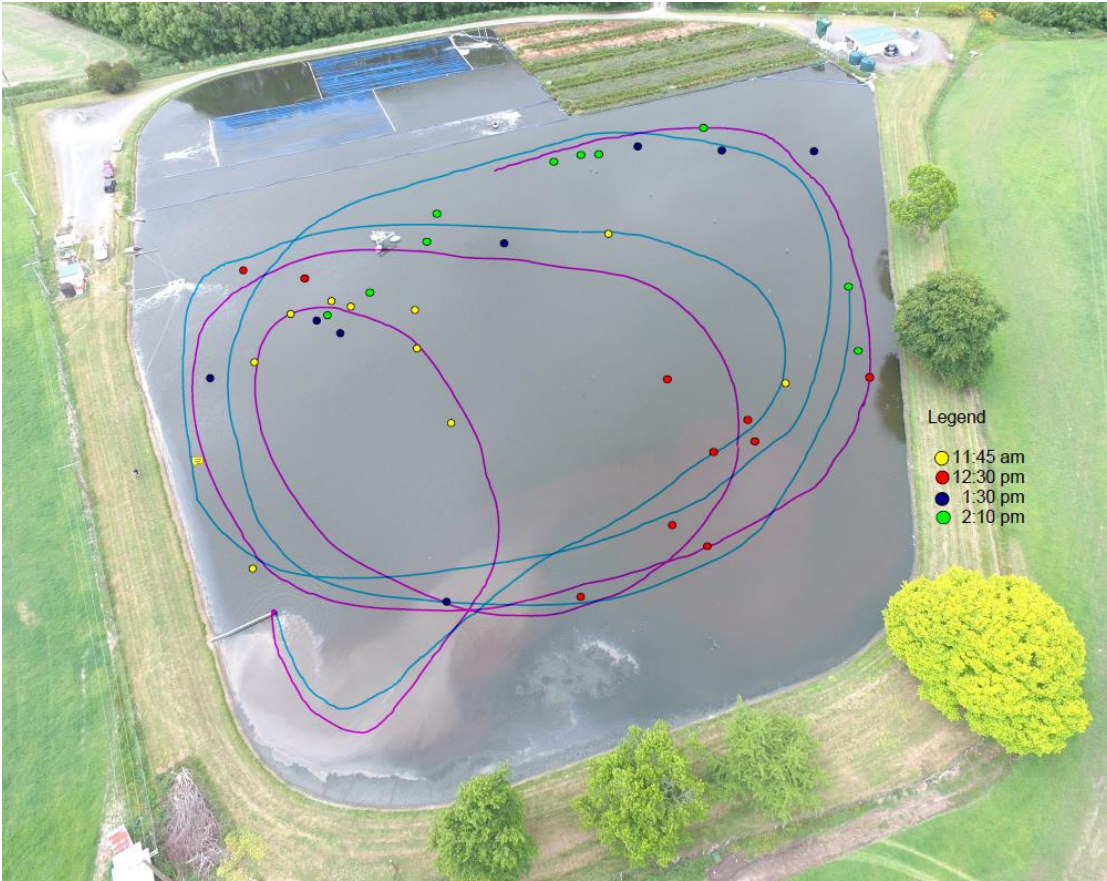
- ii) Initially the fruit appeared to track across the centre of the pond in a north easterly direction toward the outlet point. However, about half way across they veered to a north westerly track, into a flow pattern which appeared to be established by the new Reliant aerator, and back toward the inlet. On the second circuit of the pond the fruit tracked around a sludge island on the short south western side of the pond, up the long southern side. After leaving the southern side, they once again appeared to track toward the outlet but again veered away before reaching that and again tracked back toward the Reliant aerator. This time, several of the fruit tracked in behind, then past the machine.

Figure 8 – Waipawa WwTP. 14/11/2017 Grapefruit Tacking Exercise. Note 2 basic tracks taken by fruit introduced over a 30 minute period

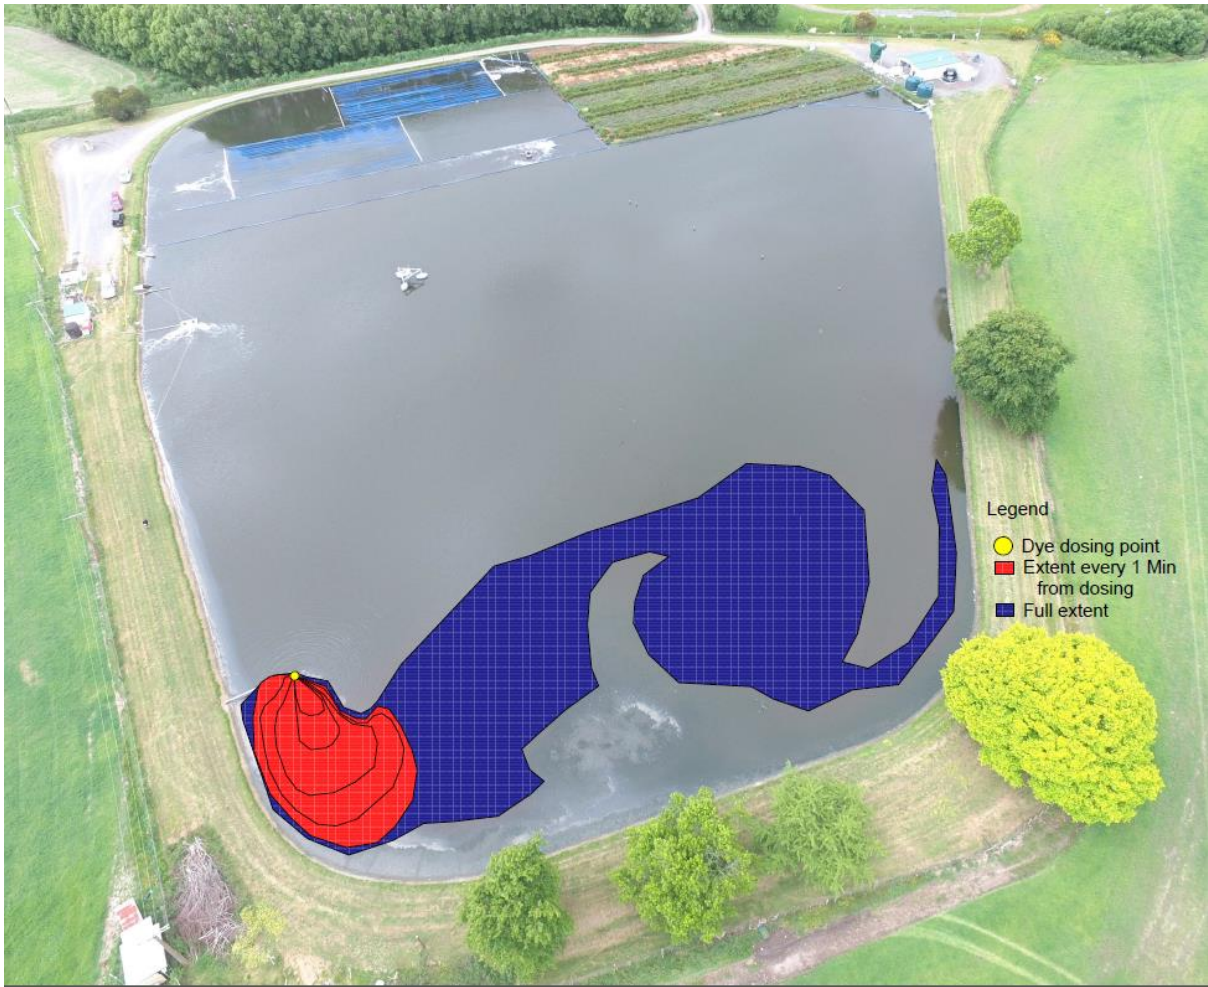
- iii) The approximate circulation pattern of the fruit has been plotted and is included in Appendix 1.
- iv) The second method was to release concentrated Rhodamine dye into the terminal pump station at the screening facility. The dye plume was tracked by drone photography until it was no longer visible. Sketches of the dispersal of the plume with time are appended. There was similarly no apparent gross short circuiting indicated by the dye release.

The combination of the grapefruit and dye tracking indicated to us that the facultative pond is not experiencing a gross short circuit and that there is likely to be a reasonably efficient use of the theoretically available hydraulic retention time in the facultative pond. While CHBDC has a quotation for it (from NIWA), it is not currently planned to proceed to a fully instrumented and sampled dye tracer study of the plant. Other investigations (refer section 4) suggest that the cost (approximately \$25,000) of the full dye tracer study would be better spent elsewhere in the treatment plant implementing corrective measures.

Figure 9 – Waipawa WwTP Dye Tracking on 14/11/2017. The further spread could not be detected by eye after approximately 1.5 hrs, indicating no concentrated stream progressing toward the outlet
