# Central Hawke's Bay District Council

Waipawa – Streets for People  
Monitoring and Evaluation Report

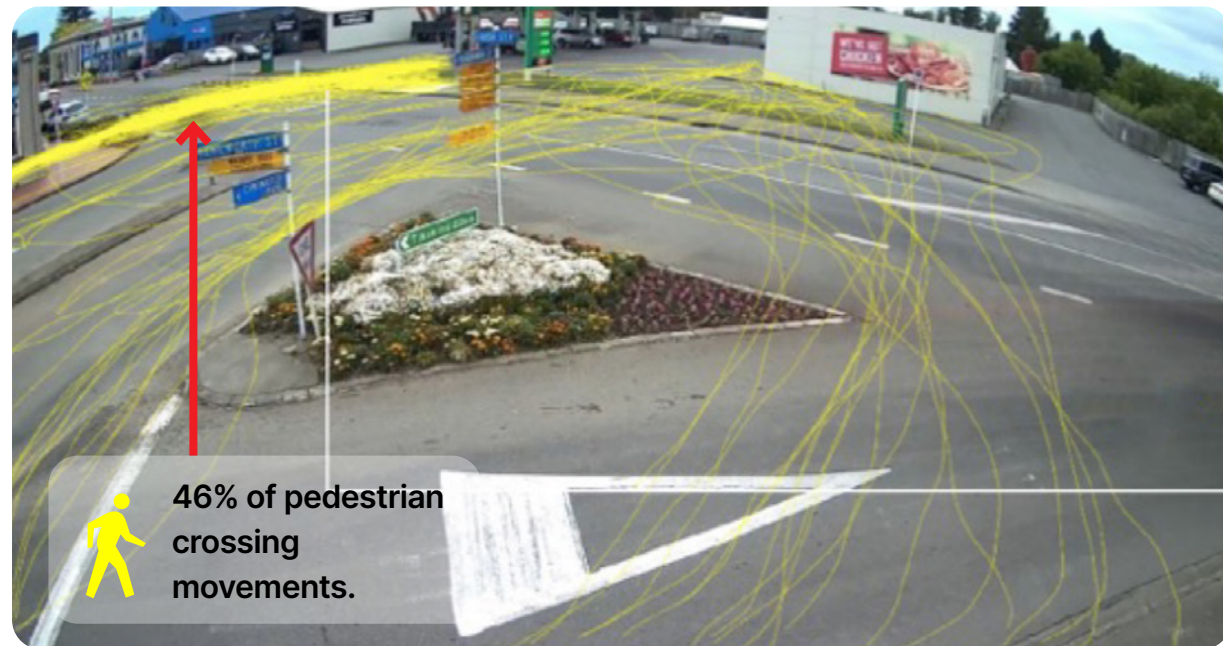
Crossing pedestrian movements have condensed into two main locations in the post-change analysis, indicating that the new infrastructure is being used.

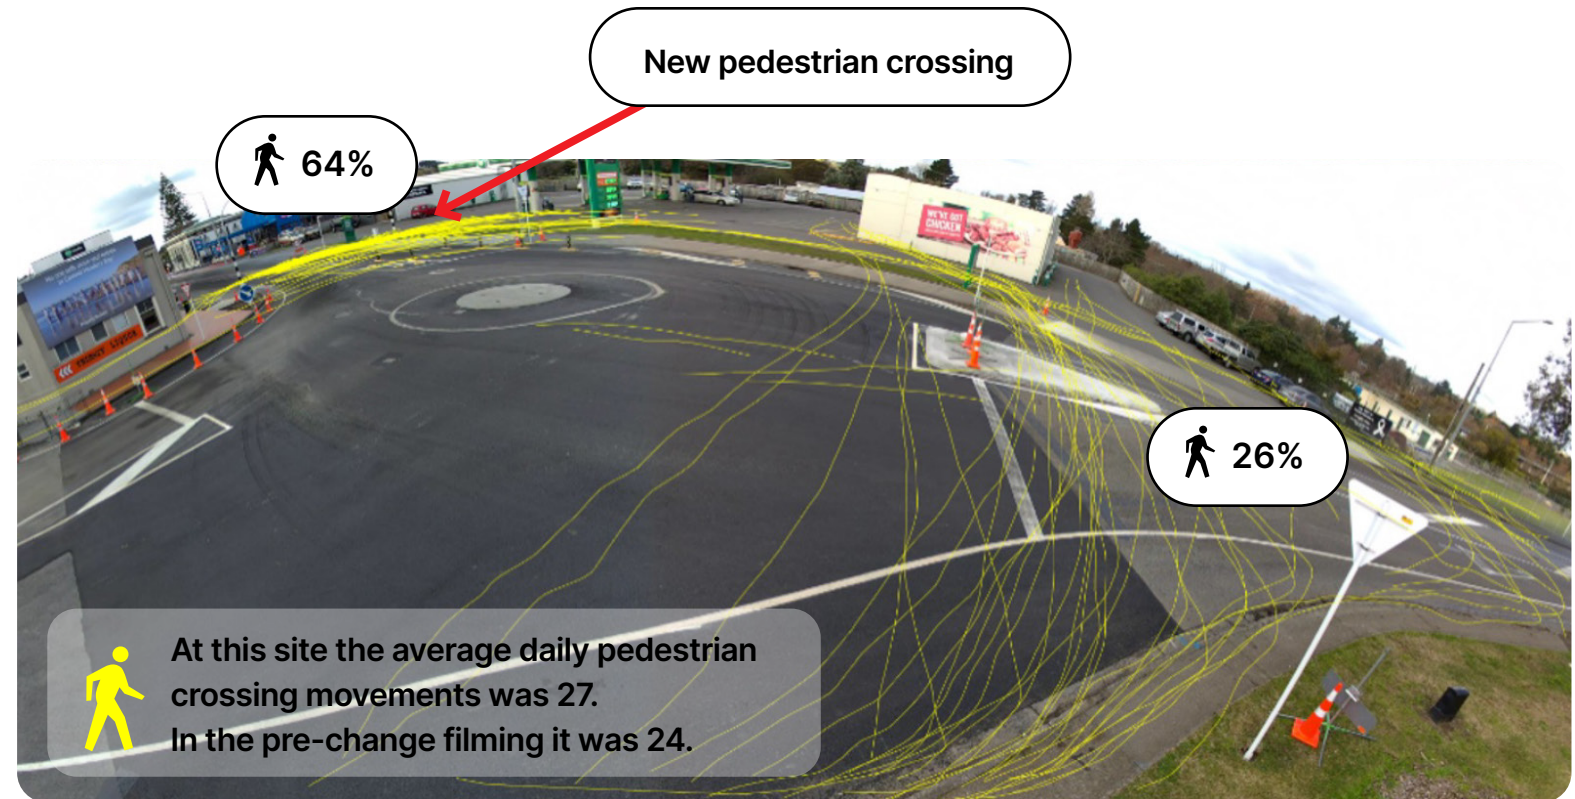
## Pre-change pedestrian crossing trajectories

Trajectories indicate that pedestrian crossing patterns have changed following the changes in the area. In the pre-change filming it was revealed that some pedestrians were crossing in the middle of the road as seen in the trajectories. **Almost half (46%) of the total pedestrian movements that crossed the road in the pre-change filming did so at the location of the new crossing.**

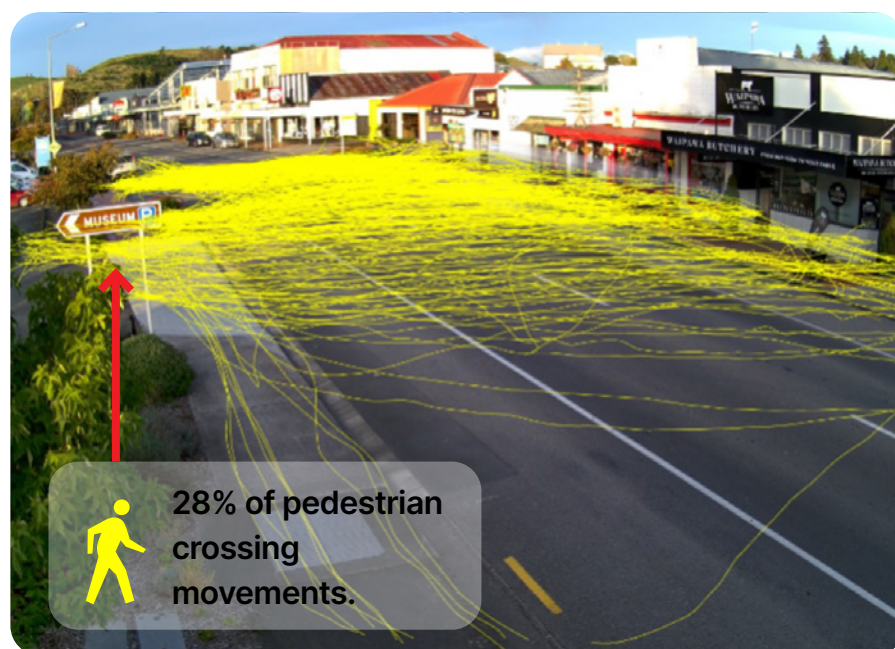
Pedestrian crossing movements have shifted further south since the pre-change and crossing into the carpark have decreased.

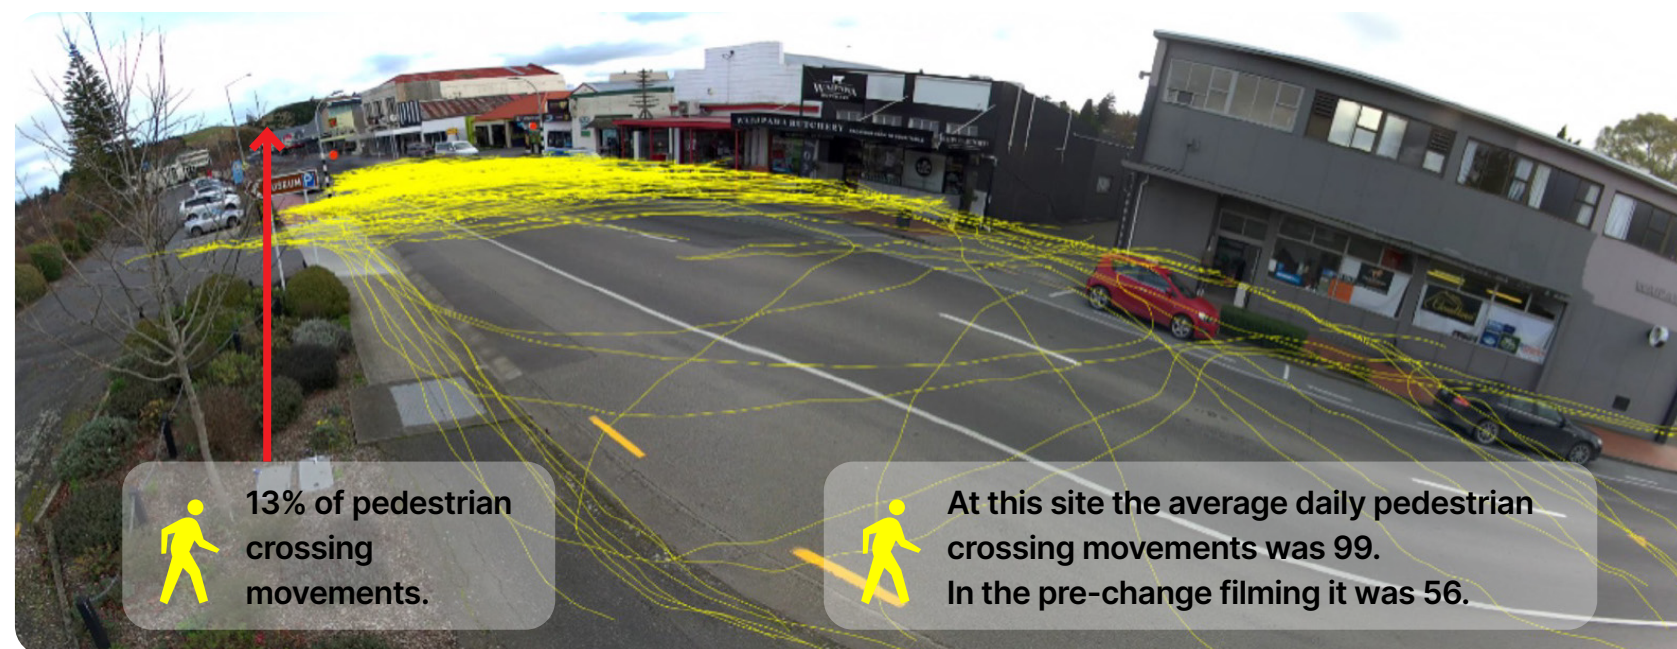
### Pre-change pedestrian crossing trajectories

Trajectories indicate that the volume of pedestrians crossing SH2 in this area has decreased. The pre-change trajectories revealed that a large number of pedestrian movements crossed SH2 between the carpark of the left and the shops including the Post Office, library and the Waipawa Butcher. **28% of the total pedestrian crossing movements at this site entered or exited via the car park on the left side of the image.**

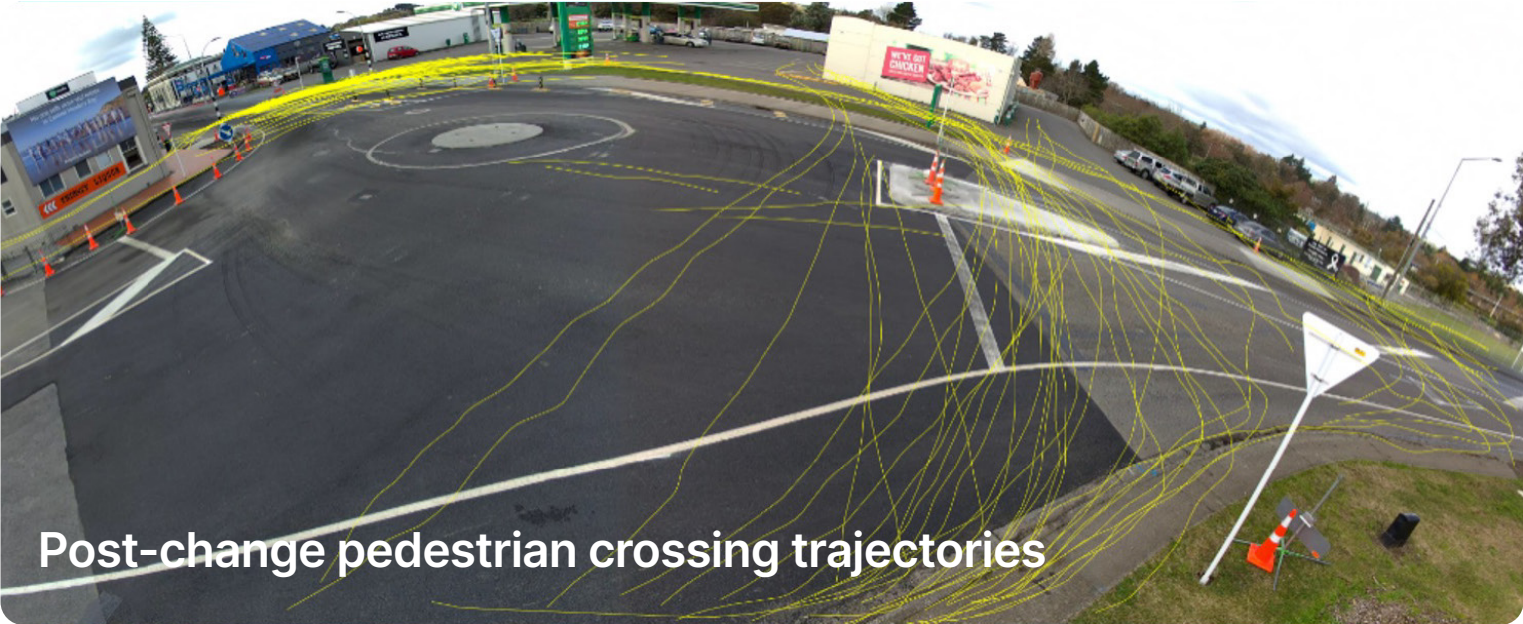
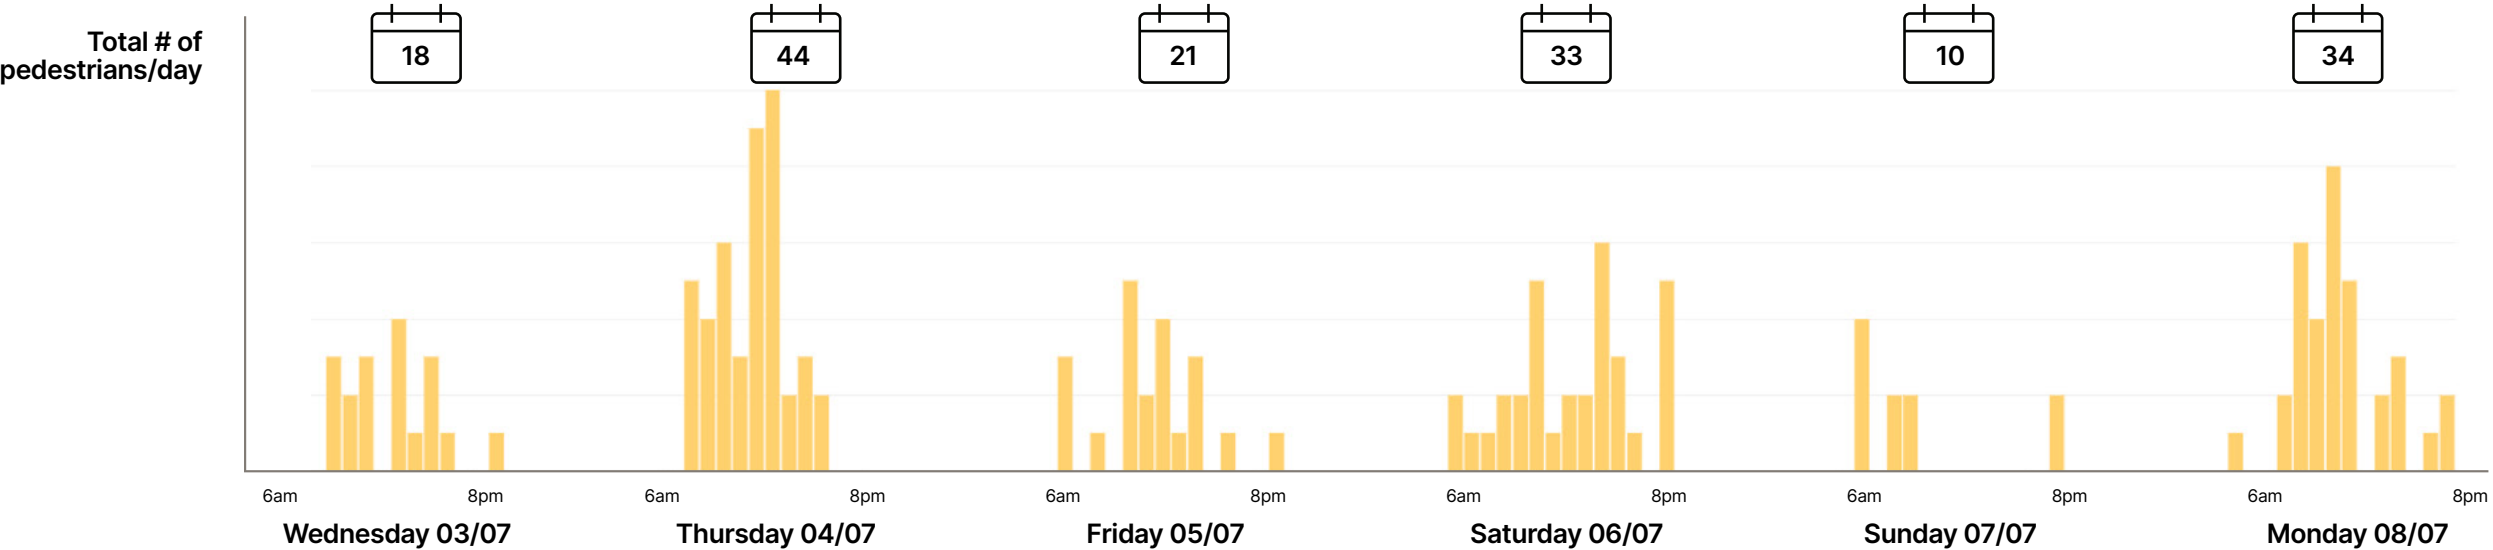
Crossing pedestrian movements on average have remained at similar volumes through pre and post analysis.

Thursday experienced the most pedestrian crossing movements. In the comparison, in the pre-change filming Thursday had the least pedestrian crossing movements and Friday had the most.

During the week pedestrian crossing movements peaked in the middle of the day and in the weekend peak times varied, with Sunday experiencing the least amount of pedestrian crossing movements throughout the week.

**At this site the average daily pedestrian crossing movements was 27. In the pre-change filming it was 24.**

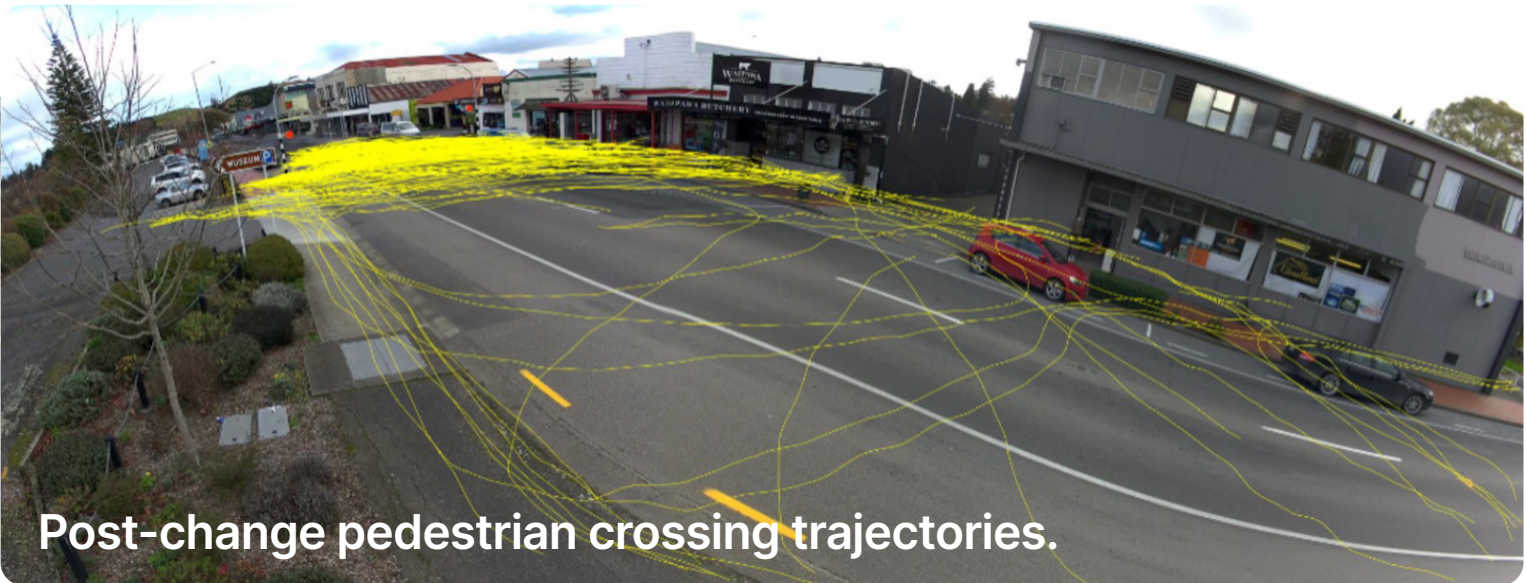
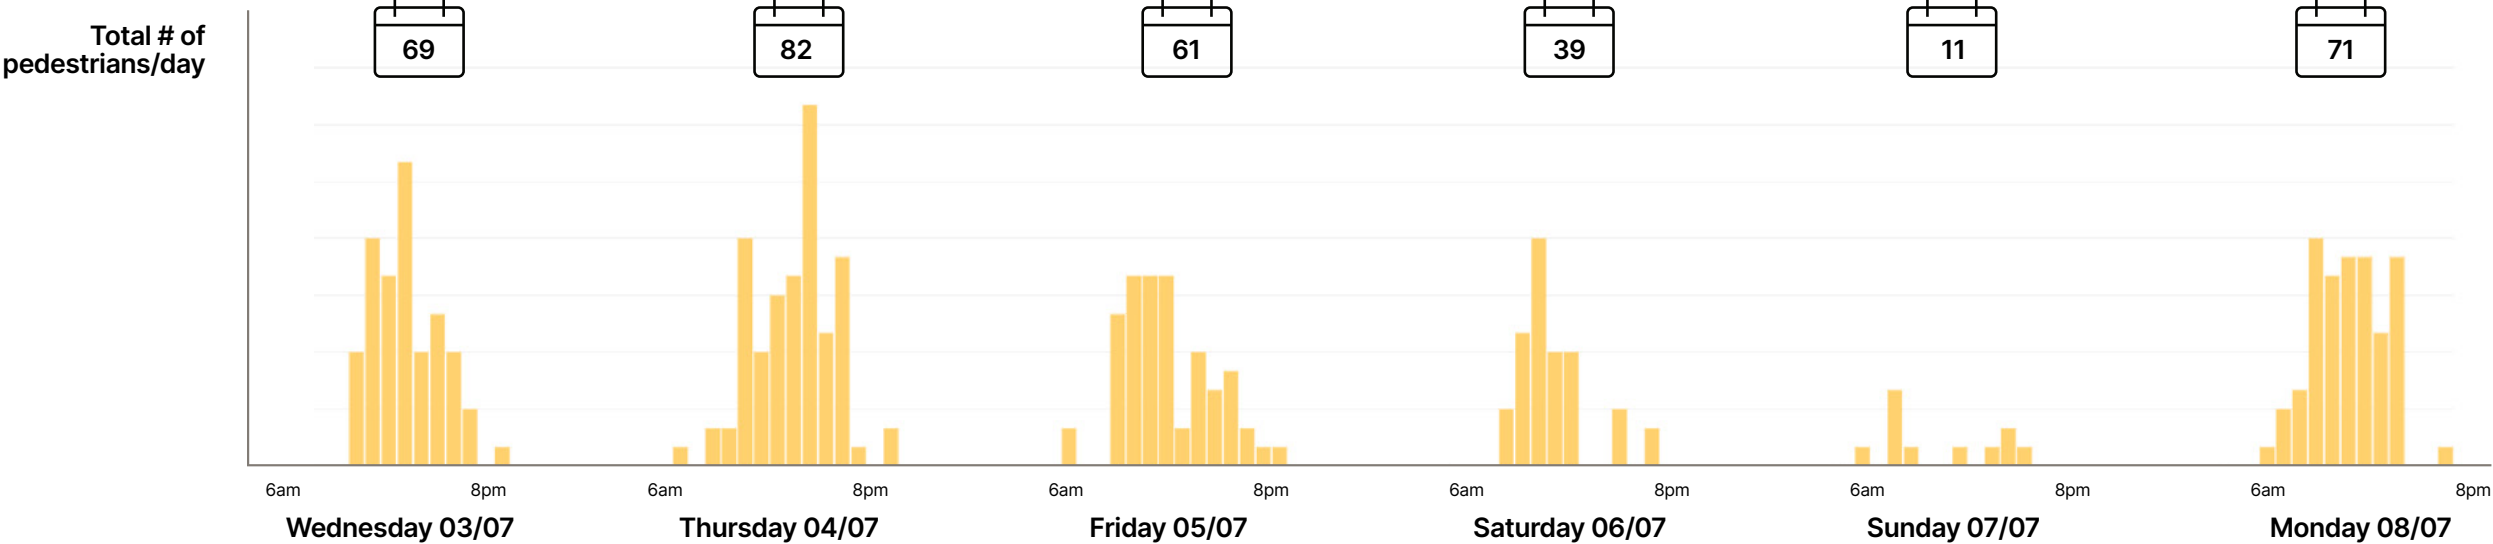
There is a significant decrease in the number of pedestrians crossing movements in this area when compared to the pre-change reporting in March 2023. This may be due the increase in crossing areas along the street allowing pedestrians more choices in where they can safely cross.

In this post-change analysis, Thursday experienced the most pedestrian crossing movements. In the pre-change analysis Saturday experienced the most and Thursday the second most.

At this site the average daily pedestrian crossing movements was 99. In the pre-change filming it was 56.
